**PERFORMANCE EVALUATION OF THE CARTER ARCHITECTURAL PANELS INC.,
“EVO™ RIVETLESS™ PANEL SYSTEM”
IN ACCORDANCE WITH AAMA 508-07 FOR PRESSURE EQUALIZATION
BEHAVIOR & WATER PENETRATION RESISTANCE**

Report to:	Carter Architectural Panels Inc. 221 E. Willis Road “A” Unit 18 Chandler, AZ 85286
Attention: cc.:	Mr. Joel McKinley Mr. Bruce Bourne
Telephone: E-mail:	(408) 899 3955 JMckinley@CarterPanels.com BBourne@ CarterPanels.com
Report No.:	16-06-M0171-2DR 7 Pages, 3 Appendices
Proposal No.:	16-006-438721
Date:	July 7, 2016

Exova was retained to evaluate the “EVO™ RIVETLESS™ Panel System” exterior wall panel system in accordance with AAMA 508-07 for pressure equalization behavior and water penetration resistance as outlined in Proposal number 16-006-438721.

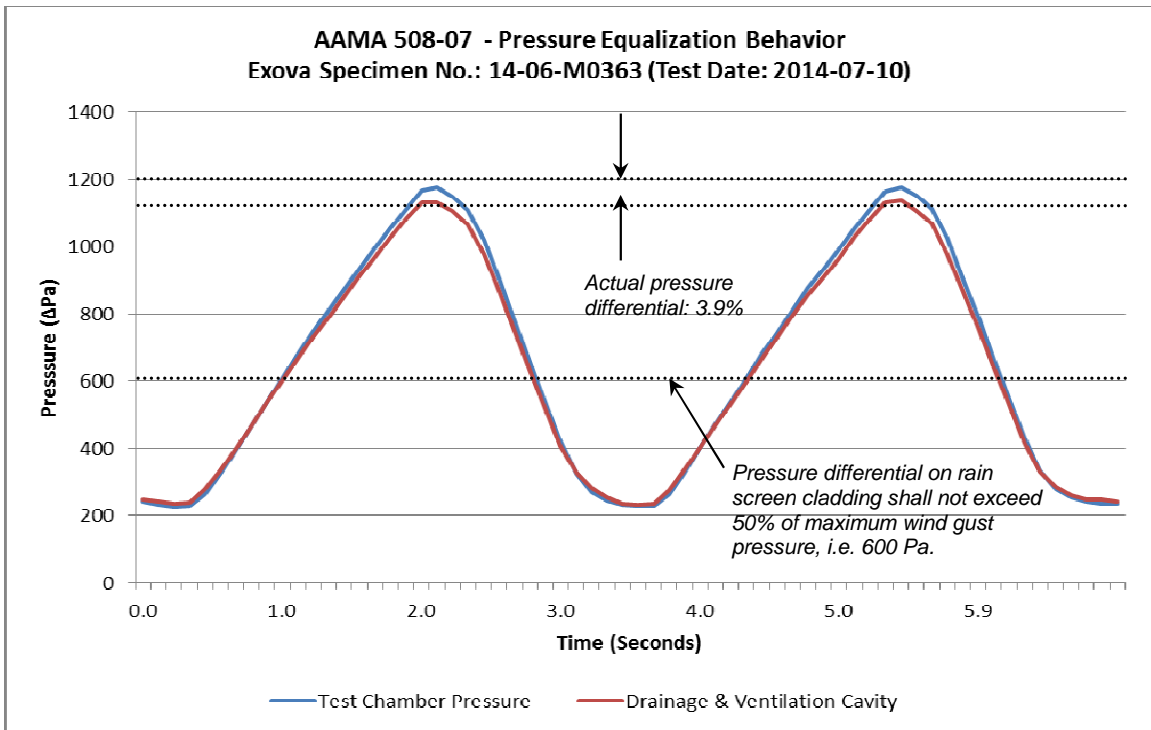
Pressure equalization graphs are located in Figures 2 (Page 4)

Figure 2 – Pressure Equalization Behavior

Table 1 – Pressure Equalization Behavior Analysis Exova Specimen Number: 14-06-M0187 / 14-06-M0363					
Compartment Tested	Maximum External Gust Pressure of Pulse (Pa)	Maximum Cavity Pressure of Pulse (Pa)	Requirements		Comments
			Pressure Differential	Maximum Time Shift of Pulse	
Primary Compartment	1178	1132	Pressure differential on rain screen cladding shall not exceed 50% of maximum wind gust pressure	< 0.08 seconds	Meets Requirement

- Air Leakage of Back-Up Wall (air / water barrier): **0.57 L/sm²**
- Ratio of cavity volume to vent area (Upper Panels): **664 m³ / m²**
- Ratio of cavity volume to vent area (Lower Panel): **680 m³ / m²**

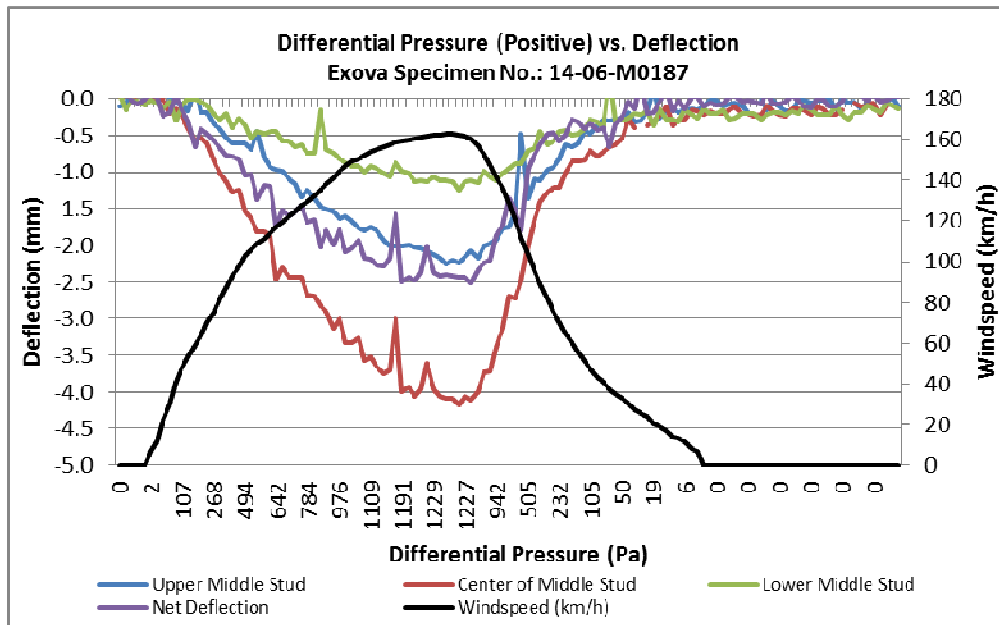
Figure 3 – Differential Pressure (Positive) vs. Deflection, ASTM E330

Table 3 – Support Wall Deflection Measurements AAMA 508-07, Section 5.8, Referencing ASTM E330 ⁽²⁾ Exova Specimen Number: 14-06-M0187 / 14-06-M0363			
Test	Requirements	Test Results	Comment
Uniform Load Deflection (Clause 5.1.2)	<p>ASTM E330 Modified: +/- 1,200 Pa</p> <p>Requirements: - No permanent damage - Report Support Wall Deflection</p>	<p>Stud Length (L) = 2,950 mm Allowable (L/180) = 16.4 mm</p> <p>Net Deflection at Design Pressure:</p> <p>+ 1,200 Pa = -2.4 mm - 1,200 Pa = 3.0 mm</p> <p>- No Permanent Damage Observed</p>	<p>Meets Requirements</p> <p>L/180 @ 1,200 Pa</p>

(2) AAMA 508-07, Section 5.8 states: "When testing the actual air/water barrier for a project specific system, perform static structural performance test ASTM E330 at 0.5, 1.0 and 1.5 times the specified positive and negative design pressures." As the testing outlined in this report was not for a project specific system, a design pressure was not outlined. However, Exova performed structural testing of the AAMA 508-07 system in accordance with ASTM E330-00 to a pressure of ±1,200 Pa (160 km/h) for informational purposes.

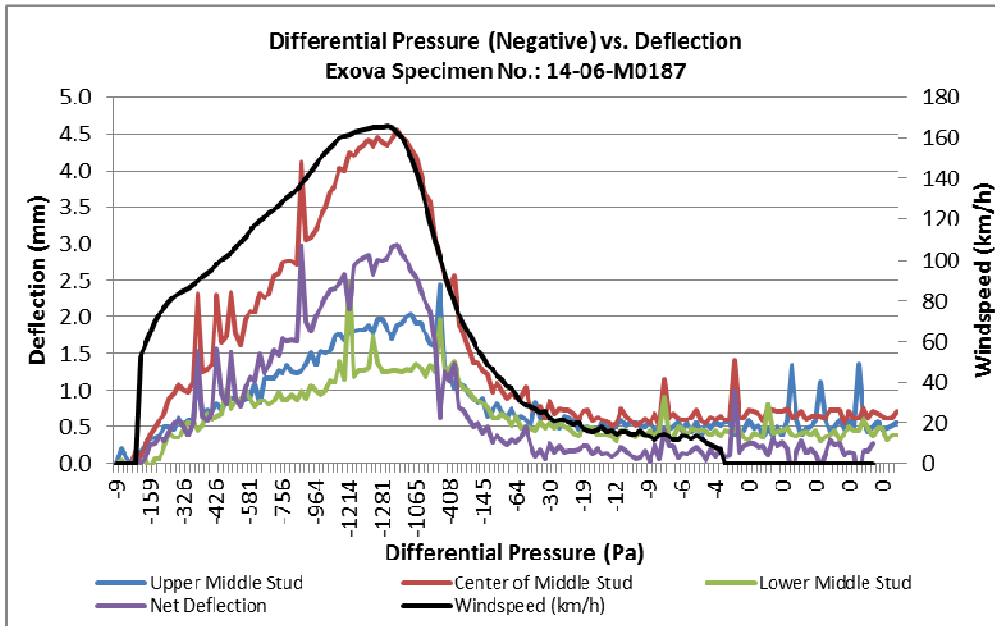
Figure 4 – Differential Pressure (Negative) vs. Deflection, ASTM E330

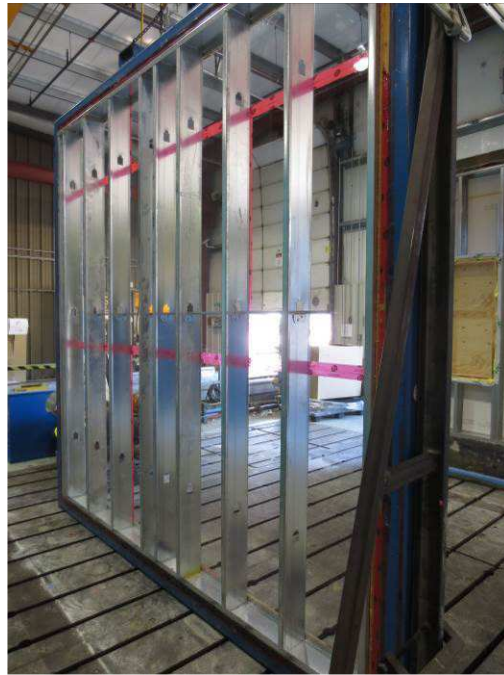
Figure B1 – Backup Wall Framing and Plexiglas Installation

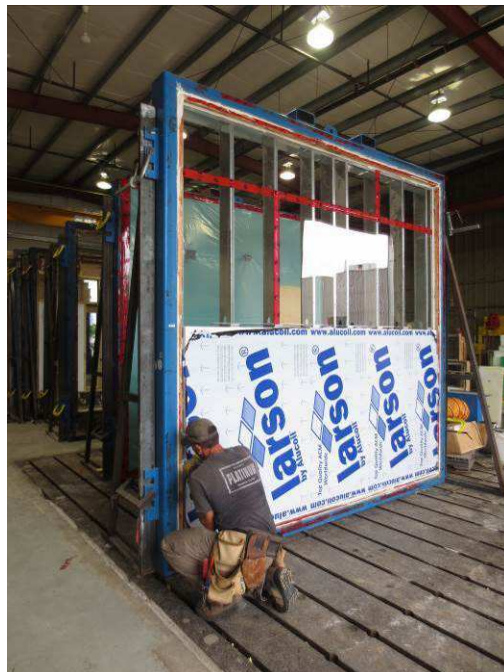
Figure B2 – Lower Panel Installation

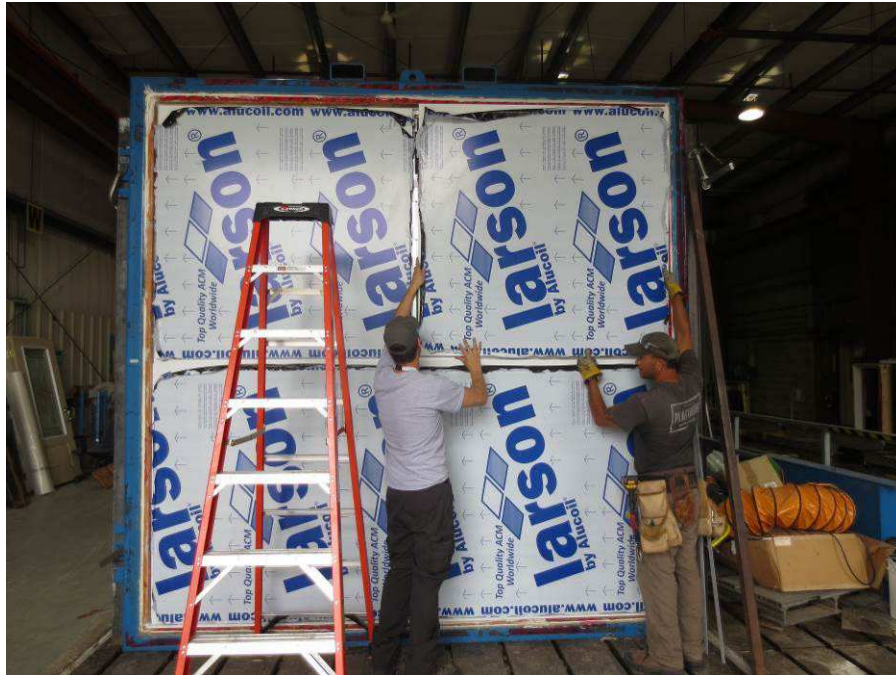
Figure B3 – Upper Panel Installation

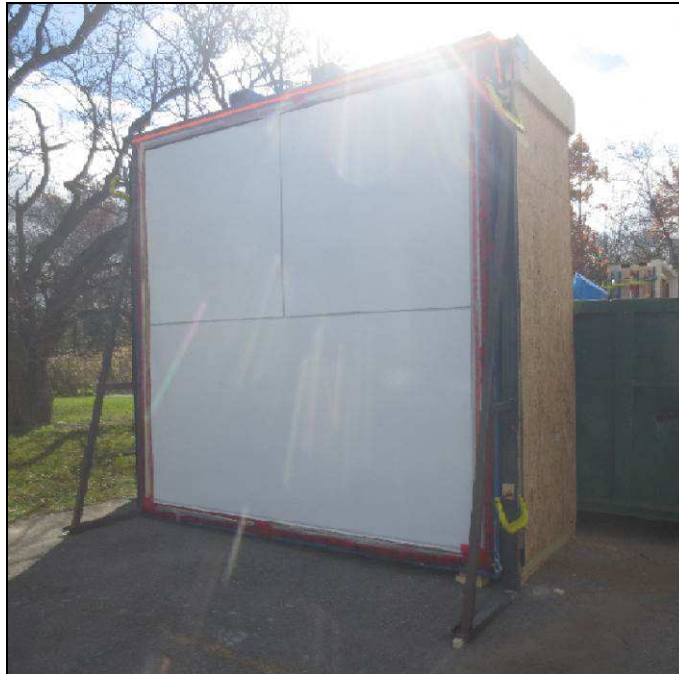
Figure C1 - Specimen Set up in front of viewing chamber

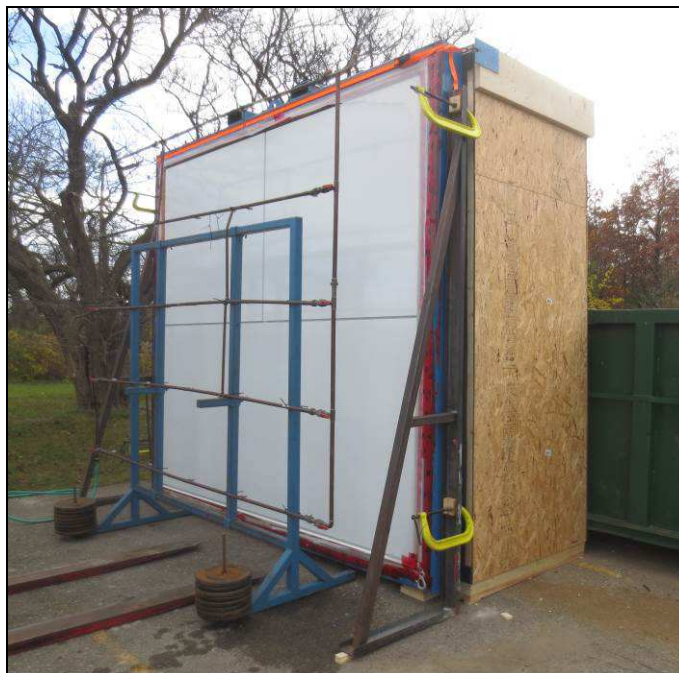
Figure C2 - Spray rack Set up for water penetration

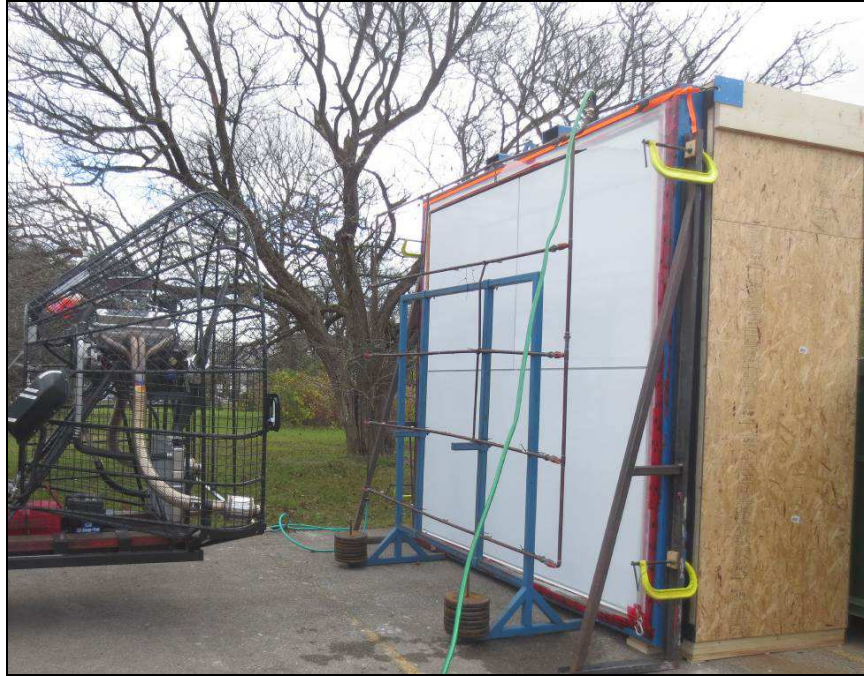
Figure C3 - Wind Machine setup to simulate Dynamic Pressure (AAMA 501.1-05)

Table 4 – Water Penetration Resistance Using Dynamic Pressure AAMA 501.1-05, Section 5.7, Referencing AAMA 501.1-05 Exova Specimen Number: 14-06-M0187 / 14-06-M0363			
Test Pressure (Pa)	Requirements	Test Results	Comment
300 Pa ⁽²⁾ (15-Minutes)	<p>All water that penetrates the exterior rain screen cladding shall be controlled and drained to the exterior. All water that contacts the air / water barrier shall be visually observed and recorded:</p> <p>a) Water mist or droplets on the air/water barrier surface; and/or b) Water in continuous stream on the air/water barrier surface.</p> <p>Failure shall be defined as water mist or water droplets appearing in excess of 5% of the air/water barrier surface, or continuous streaming at any location on the air/water barrier.</p>	<p>Water mist and/or droplets were observed.</p> <p>1.39 % of air/water barrier surface area had water misting and / or water droplets.</p> <p>All water that penetrated the exterior rain screen cladding was controlled and drained to the exterior with no continuous streaming observed.</p>	Meets Requirements
